8th Chemical Process Safety Sharing (CPSS)

CARBULIZATION in Steam Interchanger Dehydrogenation unit

Mr. Warawut Waiwasa
Process Engineer
IRPC

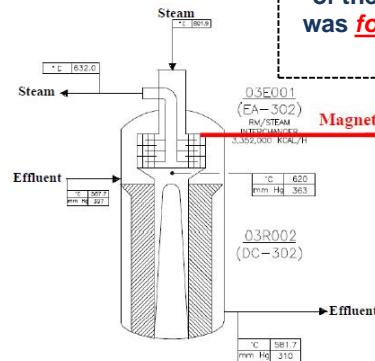
The carburization of the tubes in the first pass is confined to six or seven innermost rows of the exchanger because of **heat transfer from high temperature steam in the radial flow design**. Over a period of time, the carburized tubes flake off from inside and start to **crumble**

[From LUMMUS Sharing]

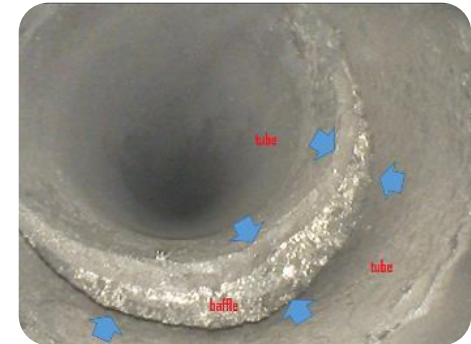
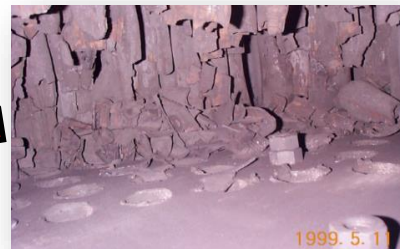
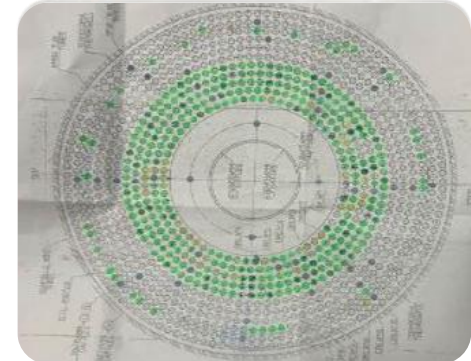
2013 and 2016: Top part of the inter-exchanger was **found initial sign of magnetic..**

Magnetic sign was found on the top part of inter-exchanger

2019: The tube was cut and inspection finding found that the tubes were failed (green color-mark).

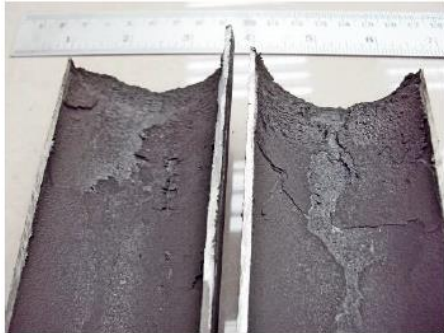
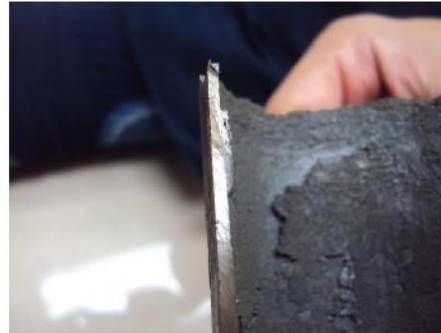
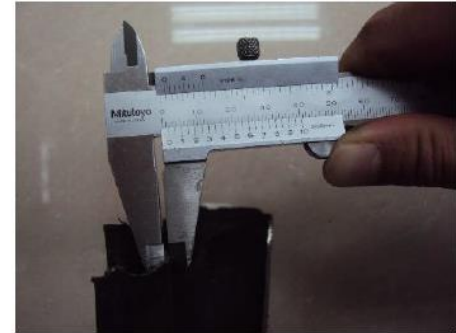
Visual testing: Internal surface was found scale and minimum thickness was 1.6 mm (design 3 mm).

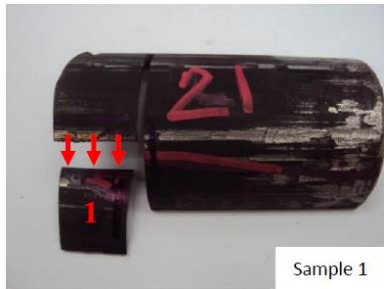
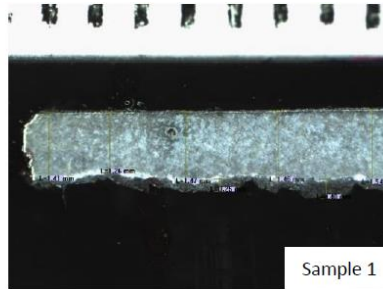
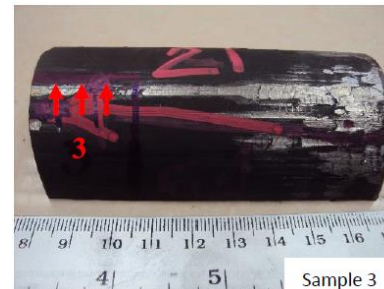
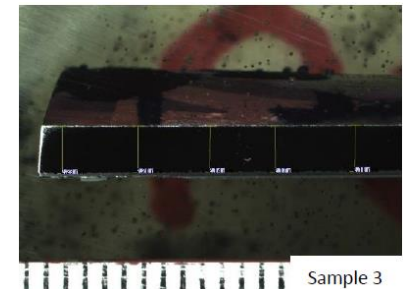
Stereo microscope: The minimum thickness of top part is 1.26 mm (sample 1) and bottom part is 2.14 mm (sample 3).

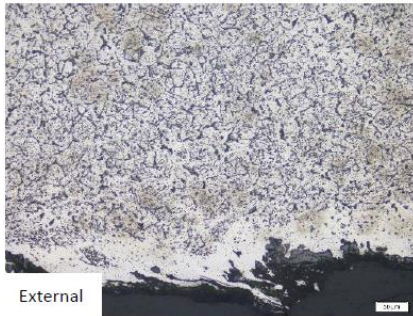
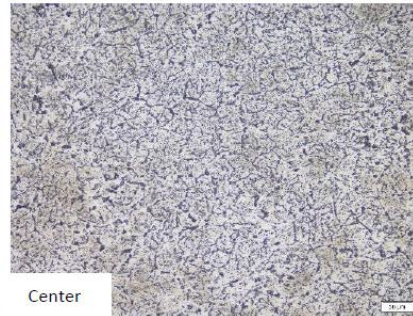
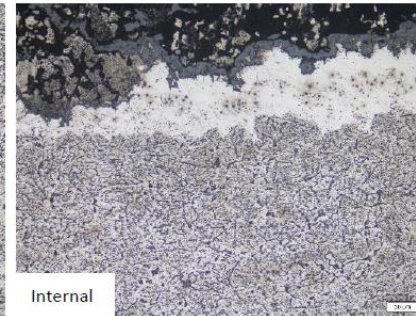
- Sample 1 (top): The internal surface was found scale, chromium depleted and degraded microstructure through cross-section thickness.

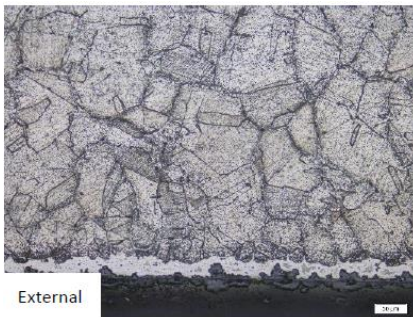
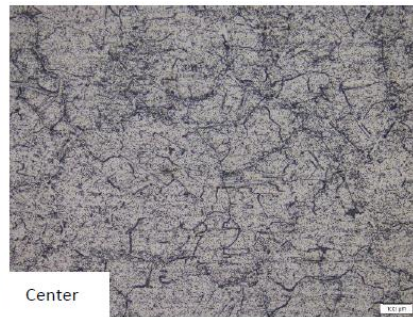
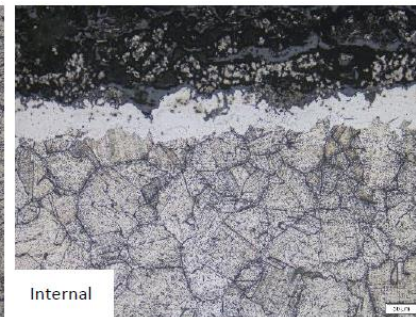
- Sample 3 (bottom): Internal surface was found scale and chromium depleted but the middle microstructure was normal.

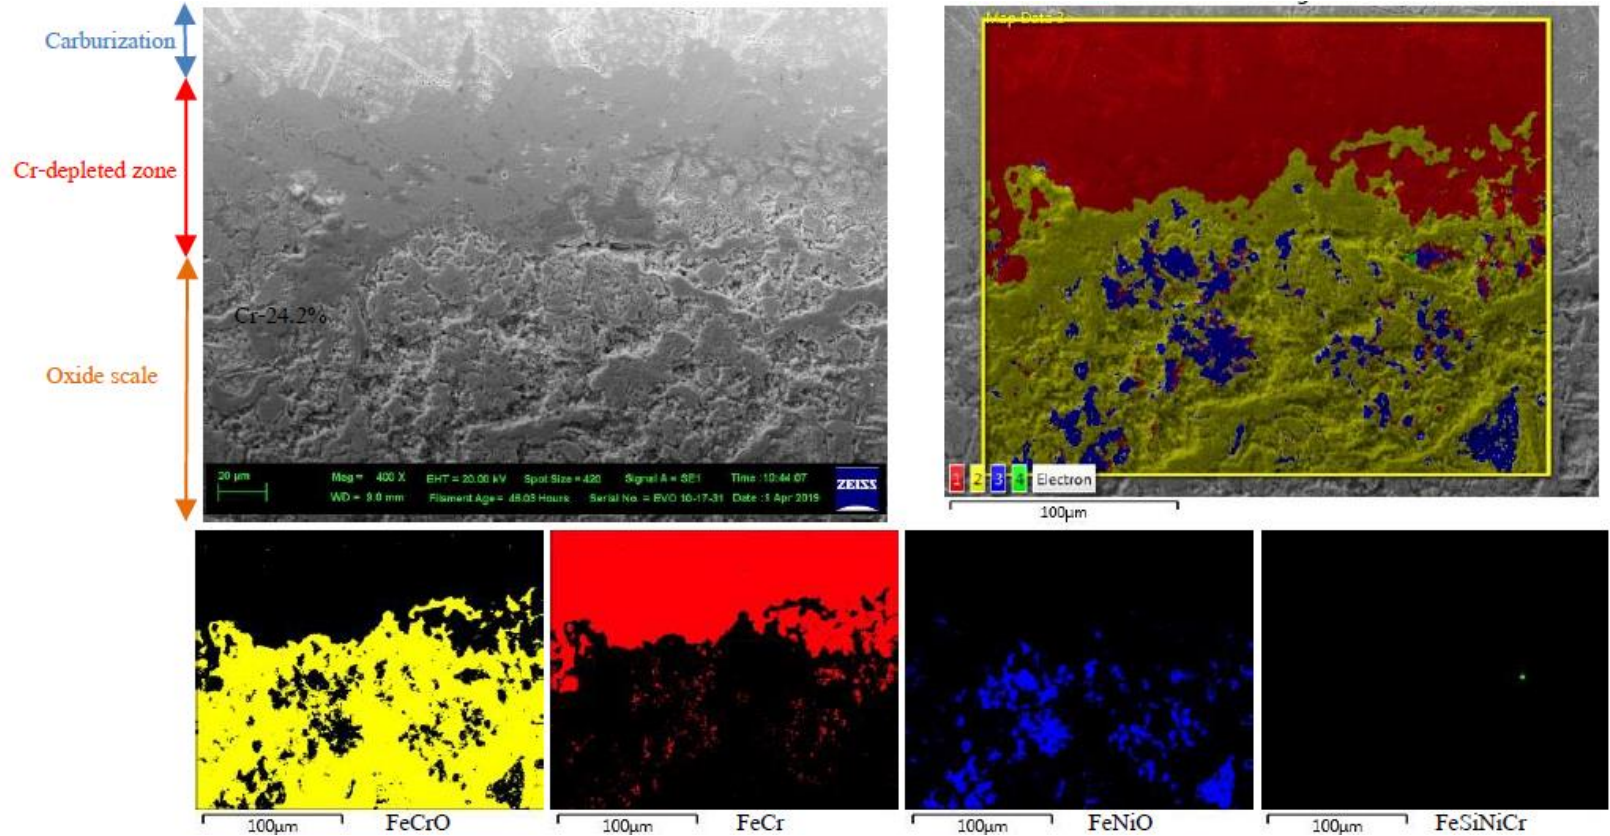
- Internal scale was found Chromium oxide layer, Chromium depleted and carburization zone

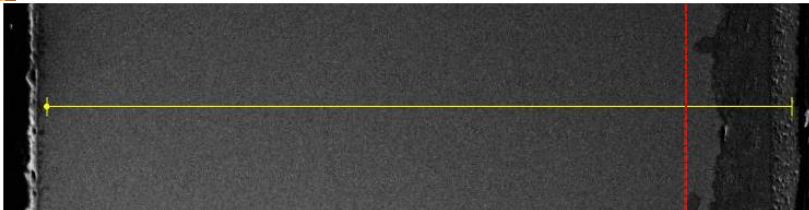
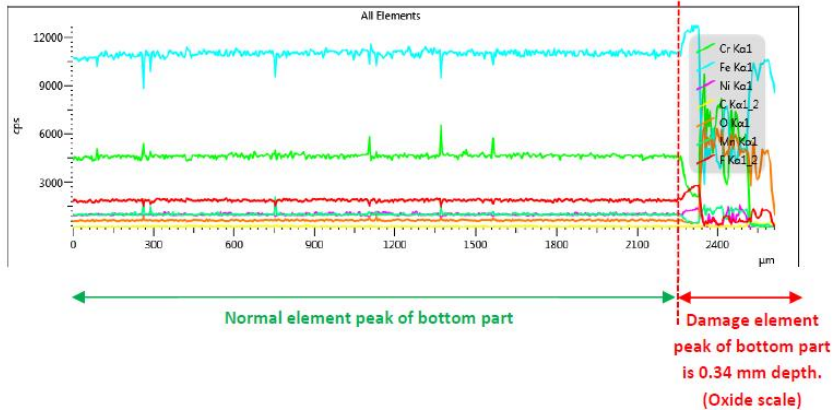
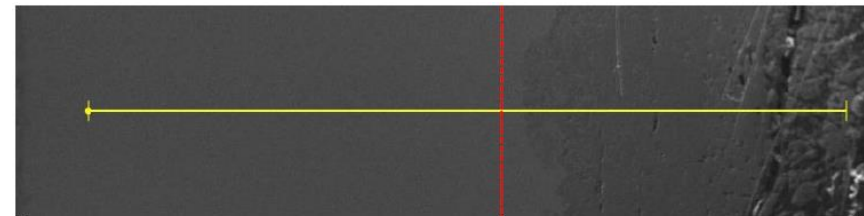
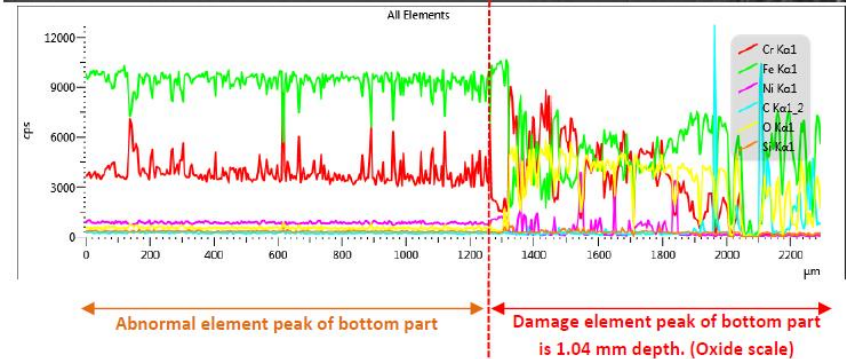
- Linescanning by EDX indicated that the sample 3 - bottom damage is 0.34 mm depth even sample 1 – top damage is 1.04 mm depth.

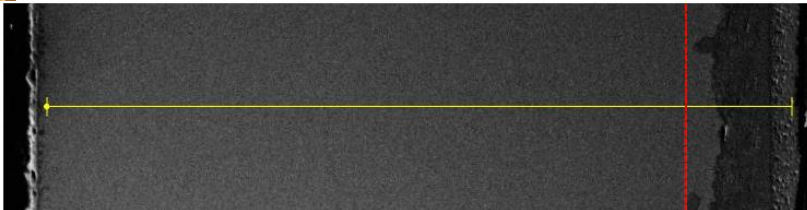
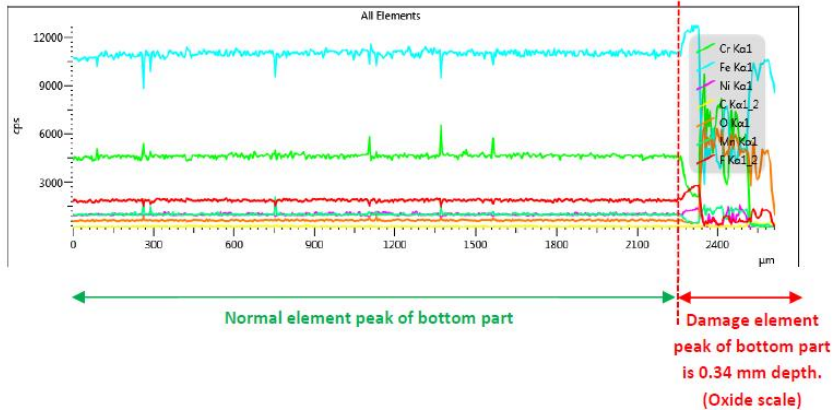
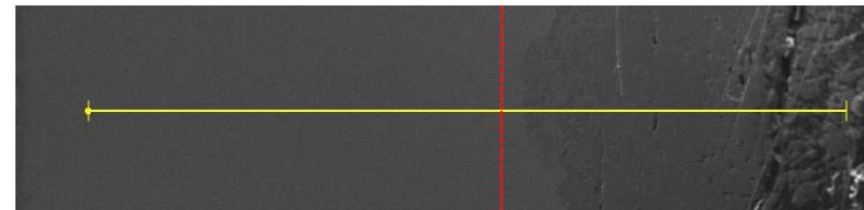
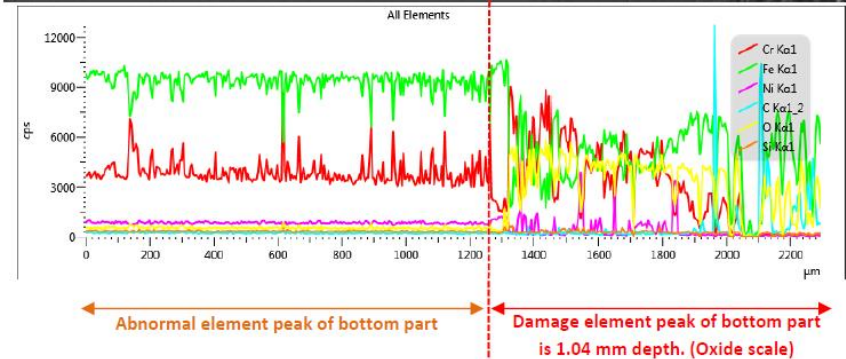
- Linescanning by EDX indicated that the sample 3 - bottom damage is 0.34 mm depth even sample 1 – top damage is 1.04 mm depth.

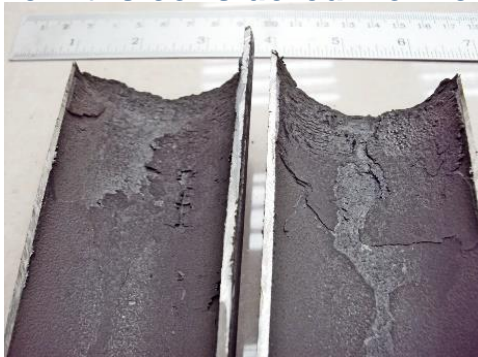
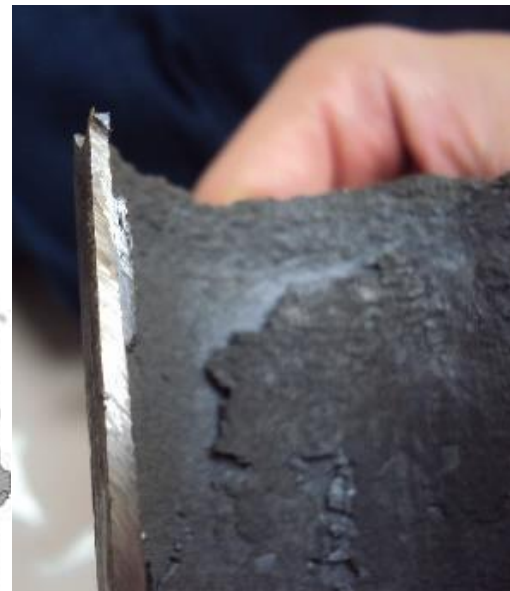
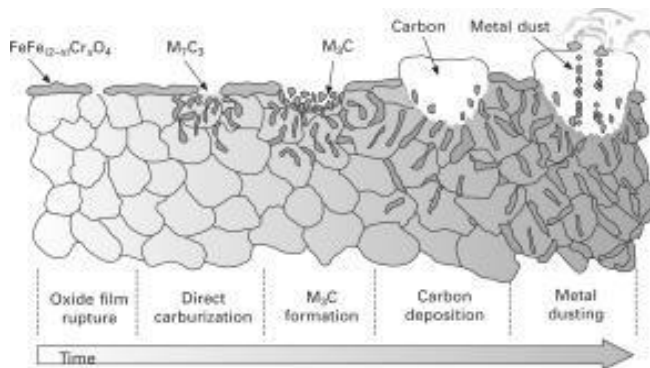
- The possible failure mode is **Metal Dusting due to the form of carburization** in accelerated **localized pitting** and **thickness loss**.
 - The carburization depth of each sample could be followed :
 - 0.3 mm of sample 3
 - All thickness of sample 1
- When it is considered from contrast of hardness result.

- Materials selection must be made based on the specific application and environment. In case Interchanger, the material upgrade from 304H(Cr 18-20%) to 310H(Cr 24-26%)
- For other process, Sulfur in the carburizing atmosphere (usually as H₂S or a disulfide), forms a protective sulfide that minimizes carburization and metal dusting. It is thought that sulfur retards the carbon transfer from the atmosphere to the metal.
