15th Chemical Process Safety Sharing (CPSS)

Topic: Aging Tank LOPC Prevention

Company : GC

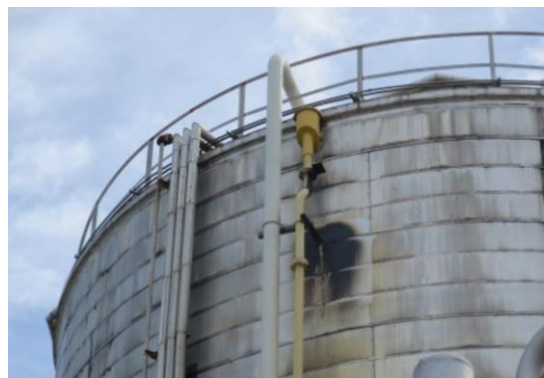
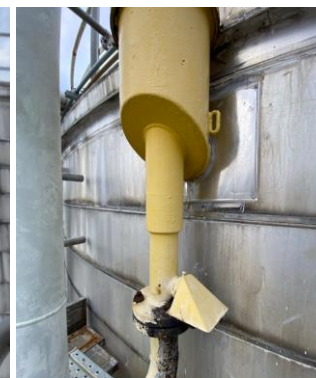
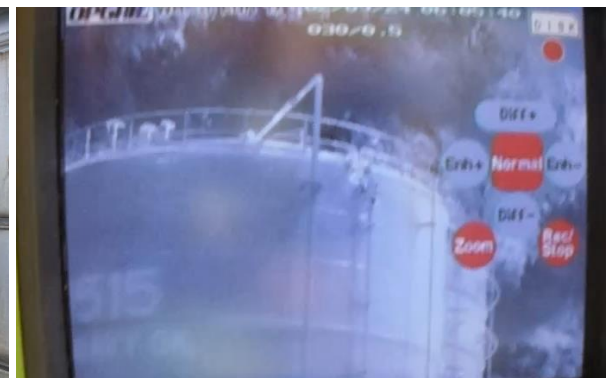
- During an FRA (Facility Risk Assessment) of a chemical storage tank, hydrocarbon vapor backflow was detected entering the foam chamber of the fire protection system.
- Vapor continued through the foam system and drained via the line drain.
- Measurement showed 100% LEL at the drain—indicating a critical explosion risk.

- The storage tank is over 30 years old, with signs of inadequate maintenance.
- Foam chamber equipment is deteriorated, increasing risks of vapor leakage and system failure.

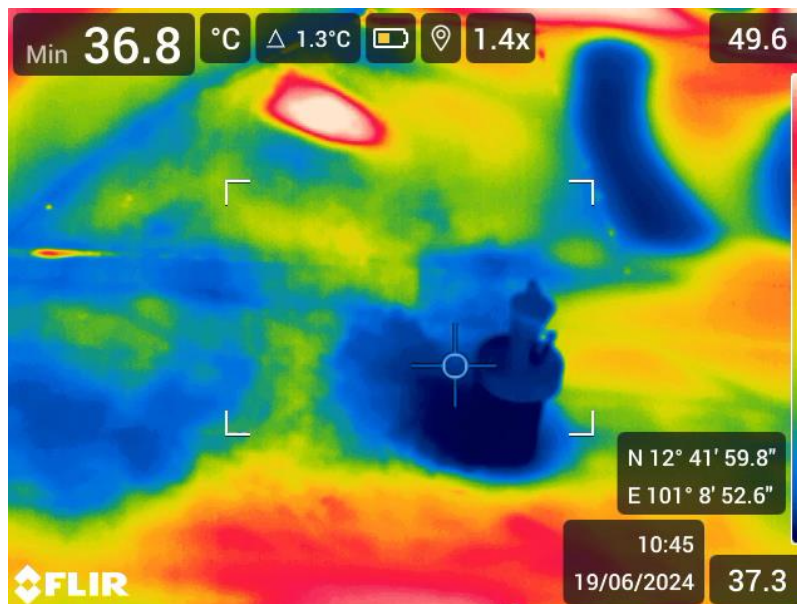
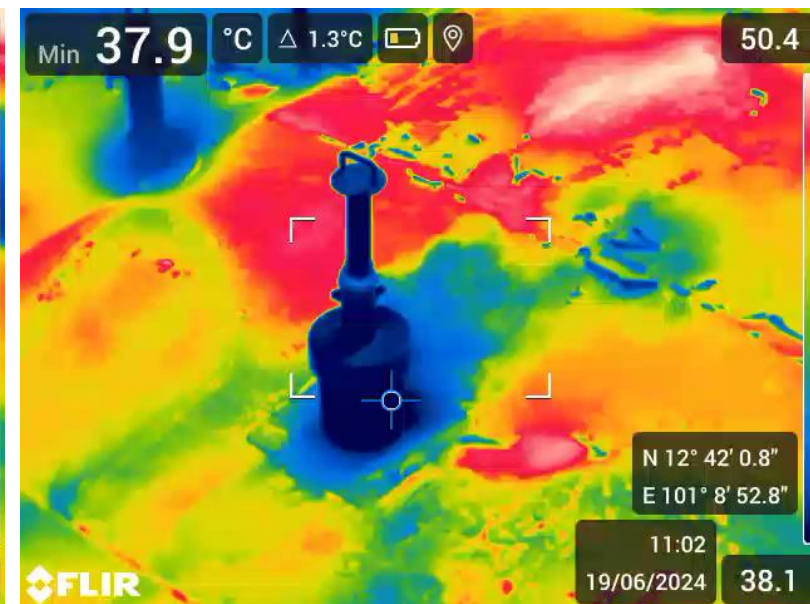
- VOC inspection equipment (**VOC Camera and Portable VOC Detectors**) was deployed to detect Hydrocarbon vapor leaks in the Tank Area.
- Findings:
 - Detected Hydrocarbon Leakage at 100% LEL.
 - VOC concentrations exceeded 300 ppm at the Foam Chambers
 - Additional high VOC levels were detected at External Floating Roof Tanks
