8th Chemical Process Safety Sharing (CPSS)

Cracking in Deaerator (V-4634)

In December 2020, Carbon steel storage vessel and stainless steel deaerator vessel (V-4634) were found crack through wall during operation.

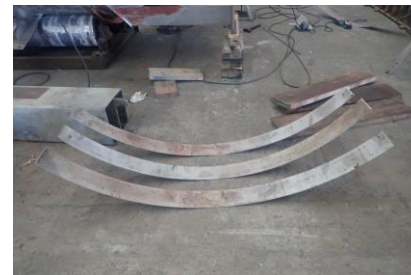
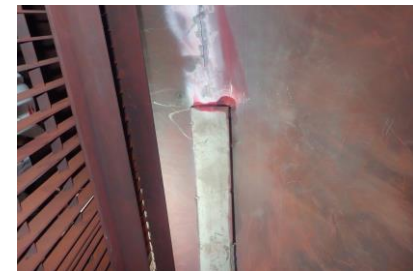
Stainless steel deaerator vessel (SS304)

Corrosion fatigue initiated by SCC was suspected due to corrosion product either from pitting or crevice in combination with thermal stresses and vibrations propagate from inside to outside of the vessel.

1. Install internal strip lining plate in order to stop crack propagation
2. Full NDE
3. Partial weld repair
4. Hydrostatic test at Design pressure

- Replace with new vessel.

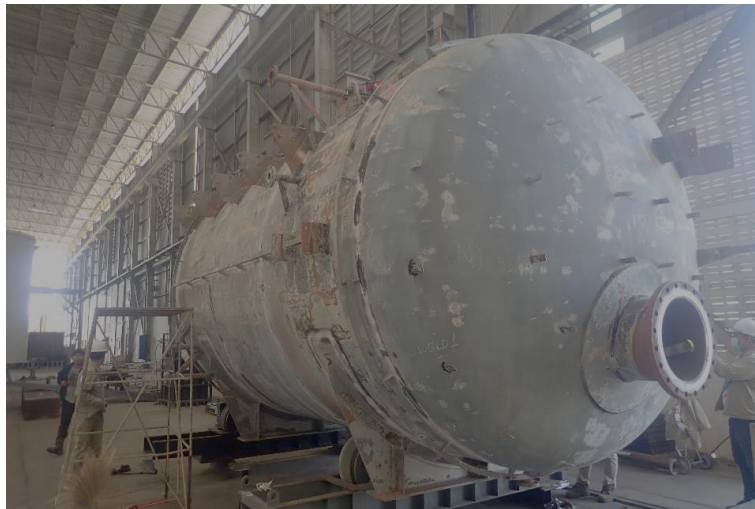
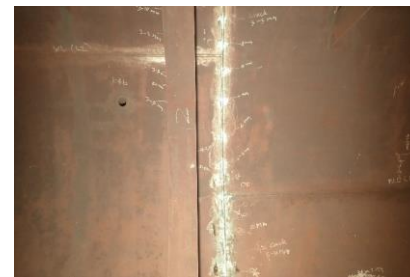
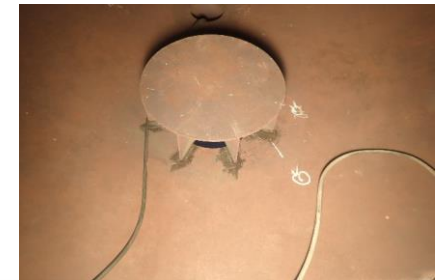
Carbon steel storage vessel

Corrosion fatigue (CF) which can happen due to residual welding stresses (No PWHT required for this vessel) /stress riser (Fillet weld at stiffener ring) initiated by corrosion product in combination with thermal stresses and vibrations.

1. Welding repair
2. PWHT in Furnace
3. Full NDE
4. Hydrostatic test at Design pressure
