9th Chemical Process Safety Sharing (CPSS)

Safety Moment

Phillips disaster of 1989

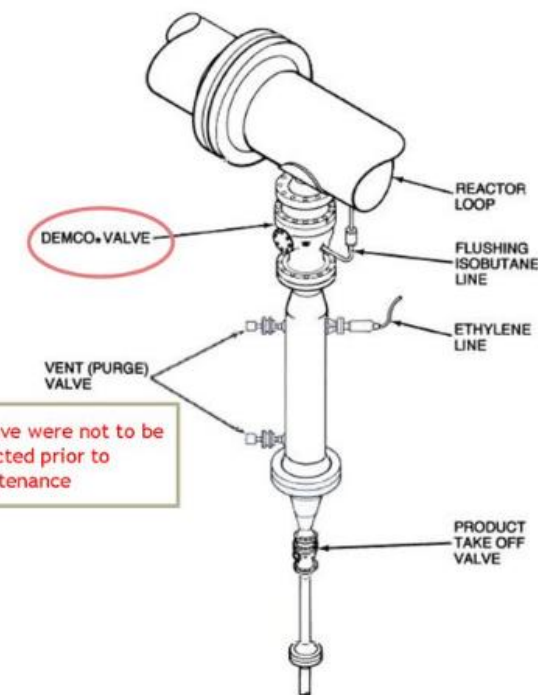
- The day before the incident scheduled maintenance work had begun to clear three of the six settling legs on a reactor
- During routine maintenance, isolation valves were closed and compressed air hoses that actuated them physically disconnected as a safety measure. The air connections for opening and closing this valve were identical and had been improperly reversed when last re-connected. As a result, the valve would have been open while the switch in the control room was in the "valve closed" position

Fig. Typical Piping Settling Leg Arrangement

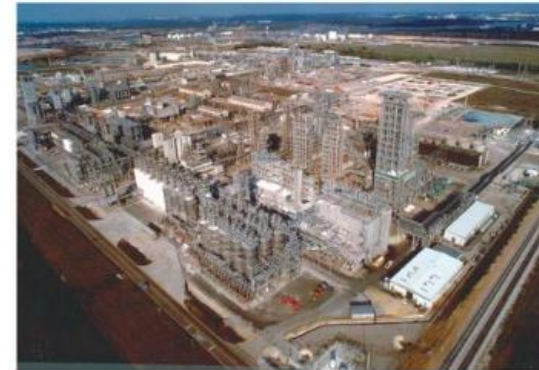
Aerial view of
the Phillips 66 plant
taken before the explosion

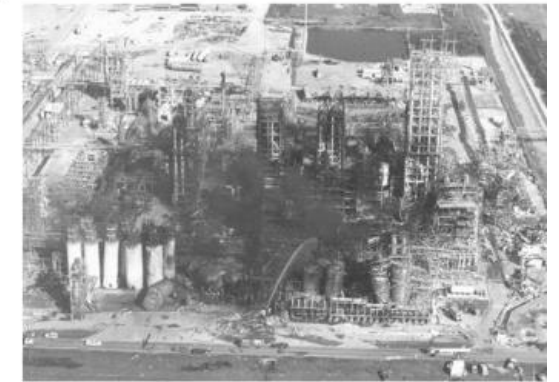
View of the Phillips 66 plant
from west to east
taken after the explosion
