# 14<sup>th</sup> Chemical Process Safety Sharing (CPSS)

## Topic: PSE Tier 1 Prevention via Maintenance and Reliability

# *PSE Tier 1 Prevention via Maintenance and Reliability*

*Experience Sharing Case Water Column Severe Corrosion  
Effect to Mechanical Integrity and How to Manage the Risk*

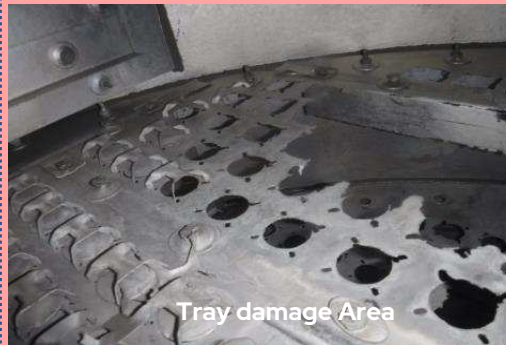
1 Tray corroded/damaged

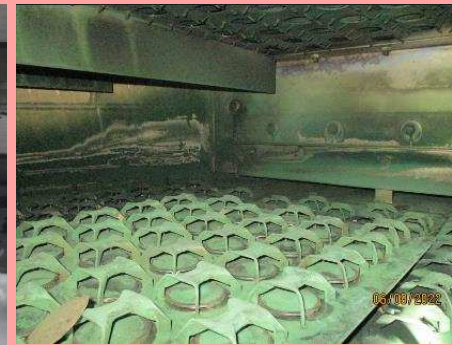
2 Green corrosion product

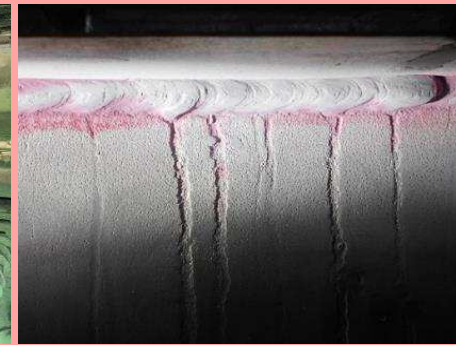
3 Localized corrosion

Acid is suspected to be a cause

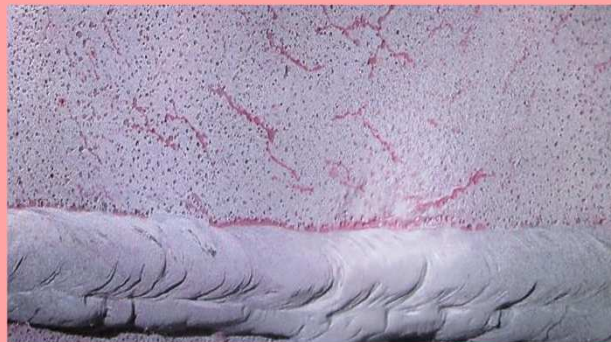
4 Pitting & Cracking (SCC with branch)

Chloride species are suspected to be a cause

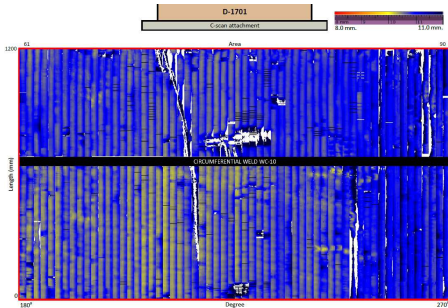
### Thickness measurement by Corrosion mapping

- Minimum thickness is 9.61 mm [10 mm]

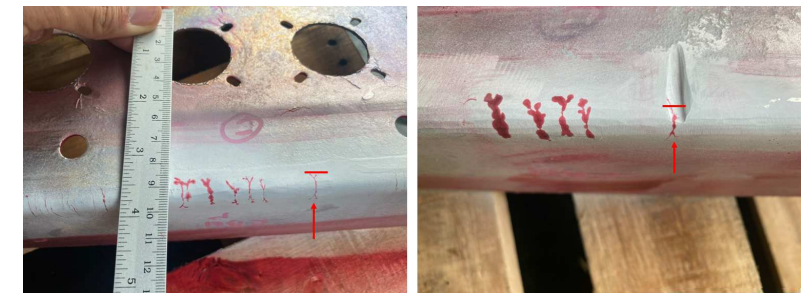
- Griding induced crack propagation.

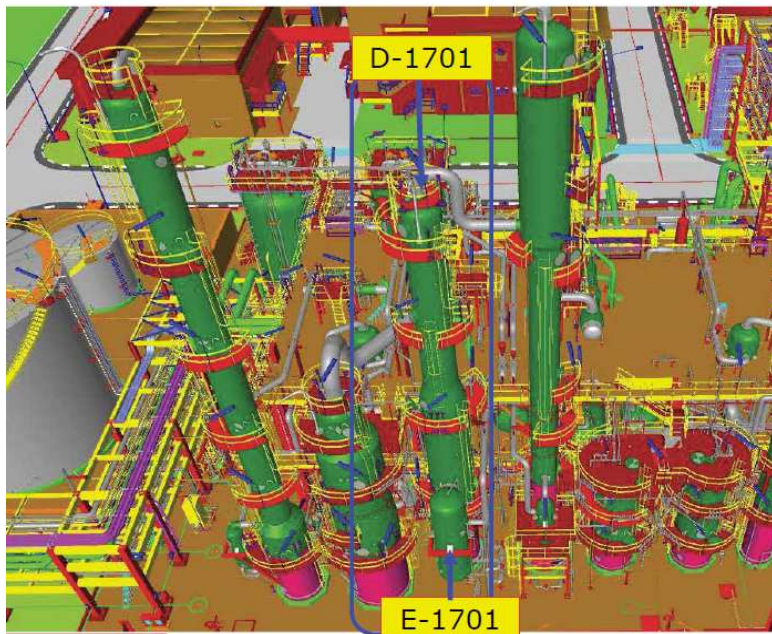
3D Water Column Drawing

- Design Pressure : 280 kPaG. / FV.
- Diameter : 1700 x 2400 mm.
- Material (Top/Bottom) : SUS 836L / SS316L
- Height : 21,250 + 7,000 (Skirt)
- Total Weight : 23.35 T.
- Internal Trays : #1 - #50

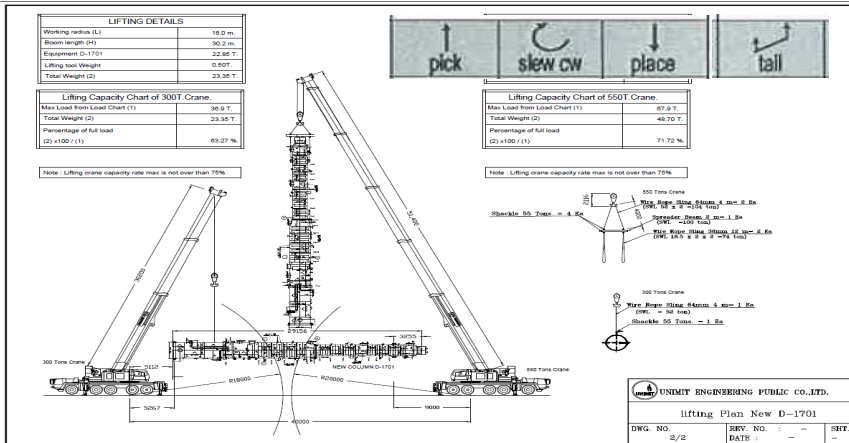
**Lifting Plan : Pick and Tail (550t + 300t)**

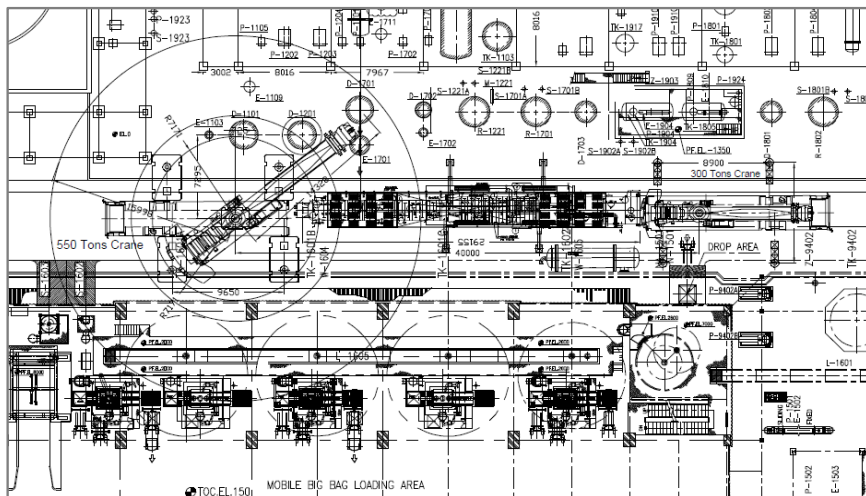
**Crane Location : Road W = 6.0 M.**

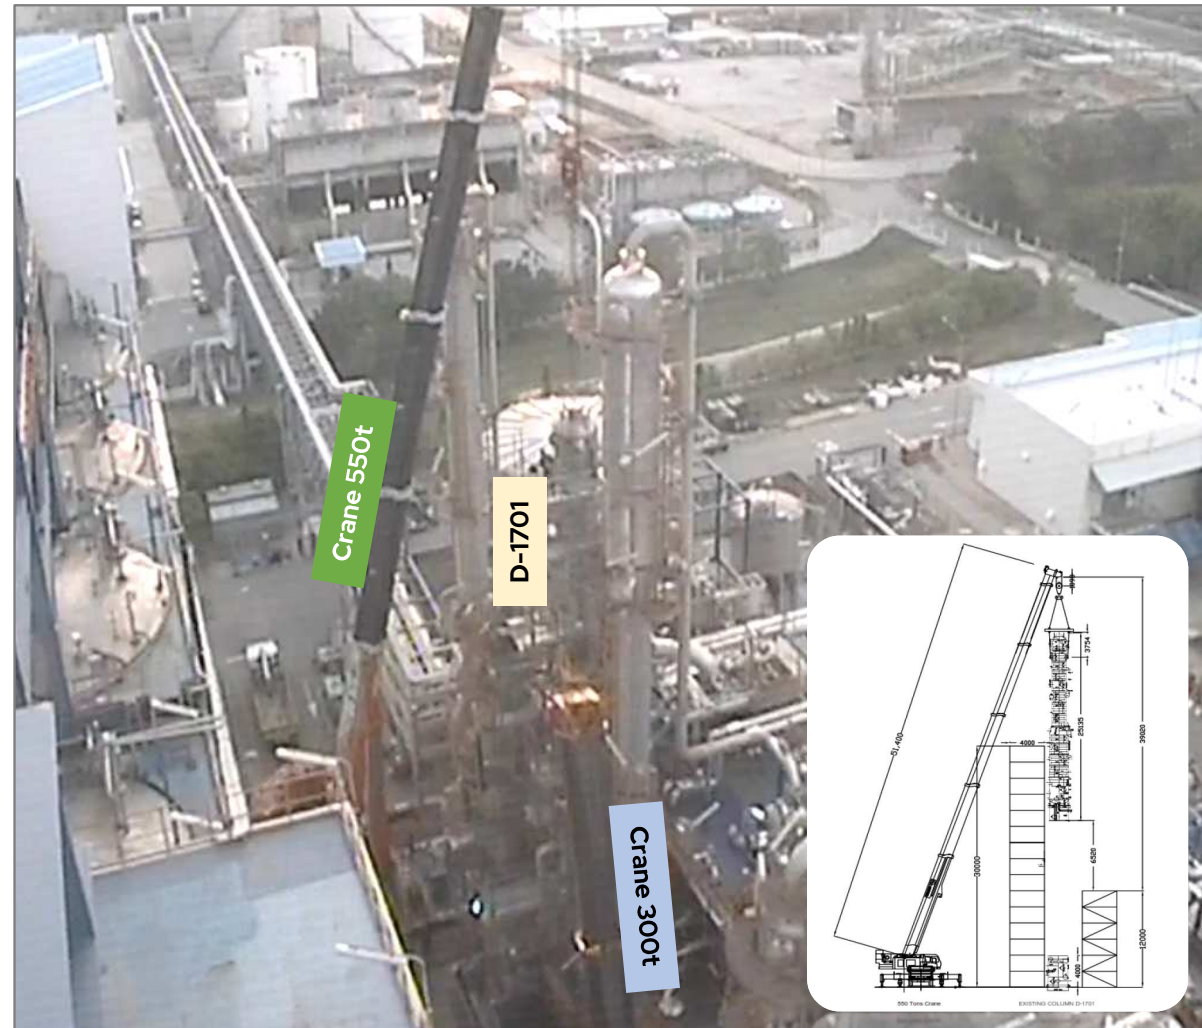
**Lifting Arrangement : Separate column and skirt**

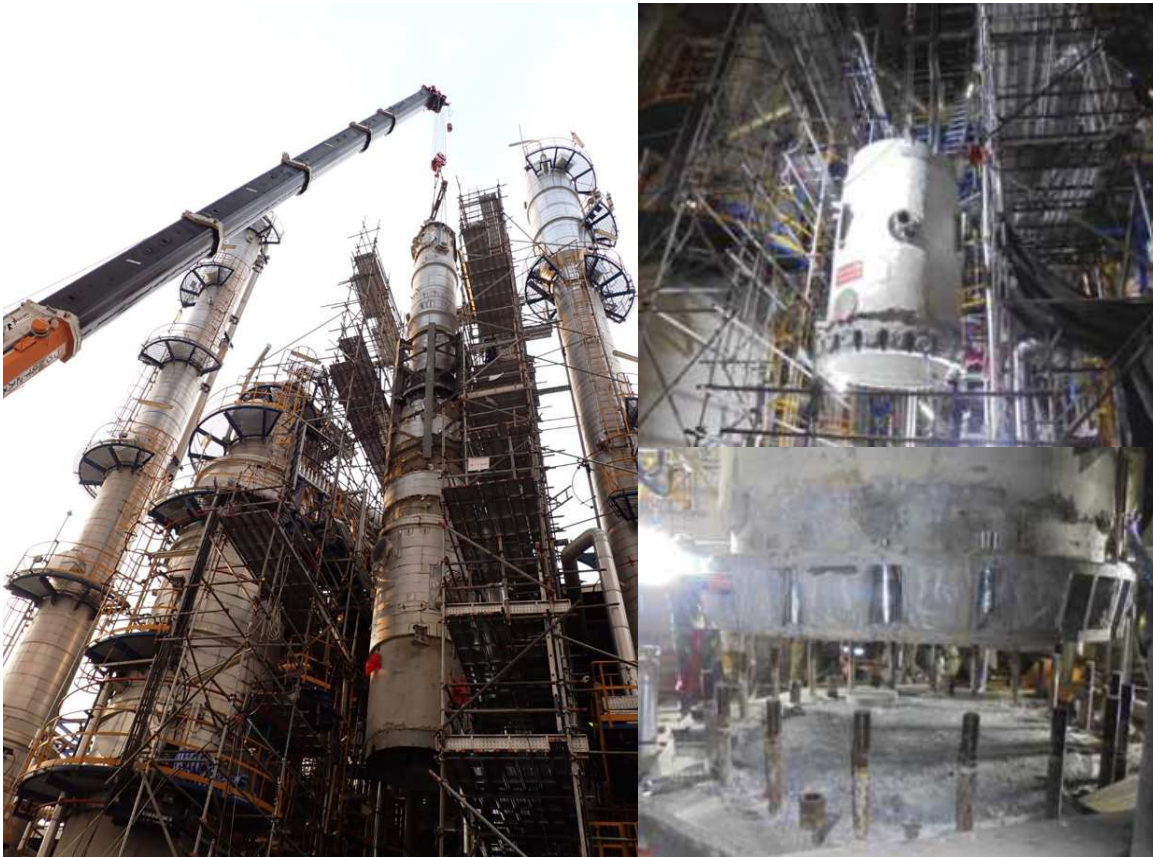
**Existing column Removal :** Focus to avoid anchor bolt and padding damage

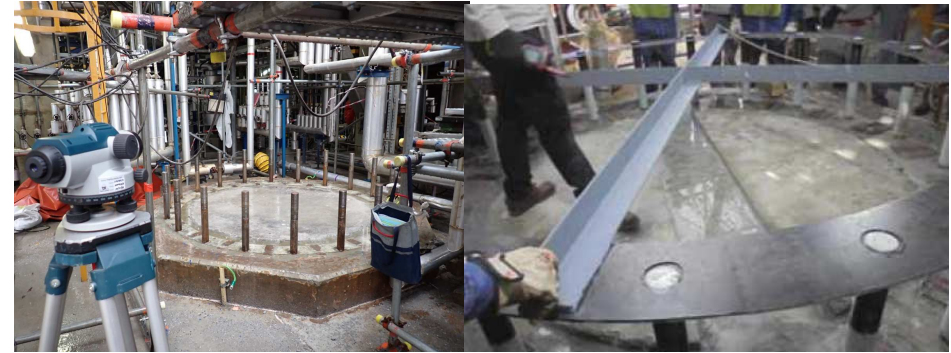
**Padding and anchor bolt inspection :**  
To Ensure bolt arrangement and pad leveling
