# Transforming Thermal Images into Energy Savings using AI-Based Integrity Assessment of Insulated Piping Systems

**Assoc. Prof. Dr. Chanin Panjapornpon**

Department of Chemical Engineering,  
Faculty of Engineering,  
Kasetsart University

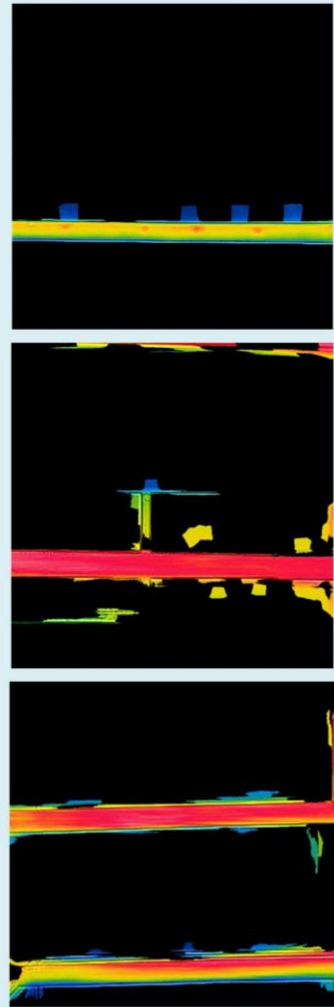
Segmented pipe mask  
after classification

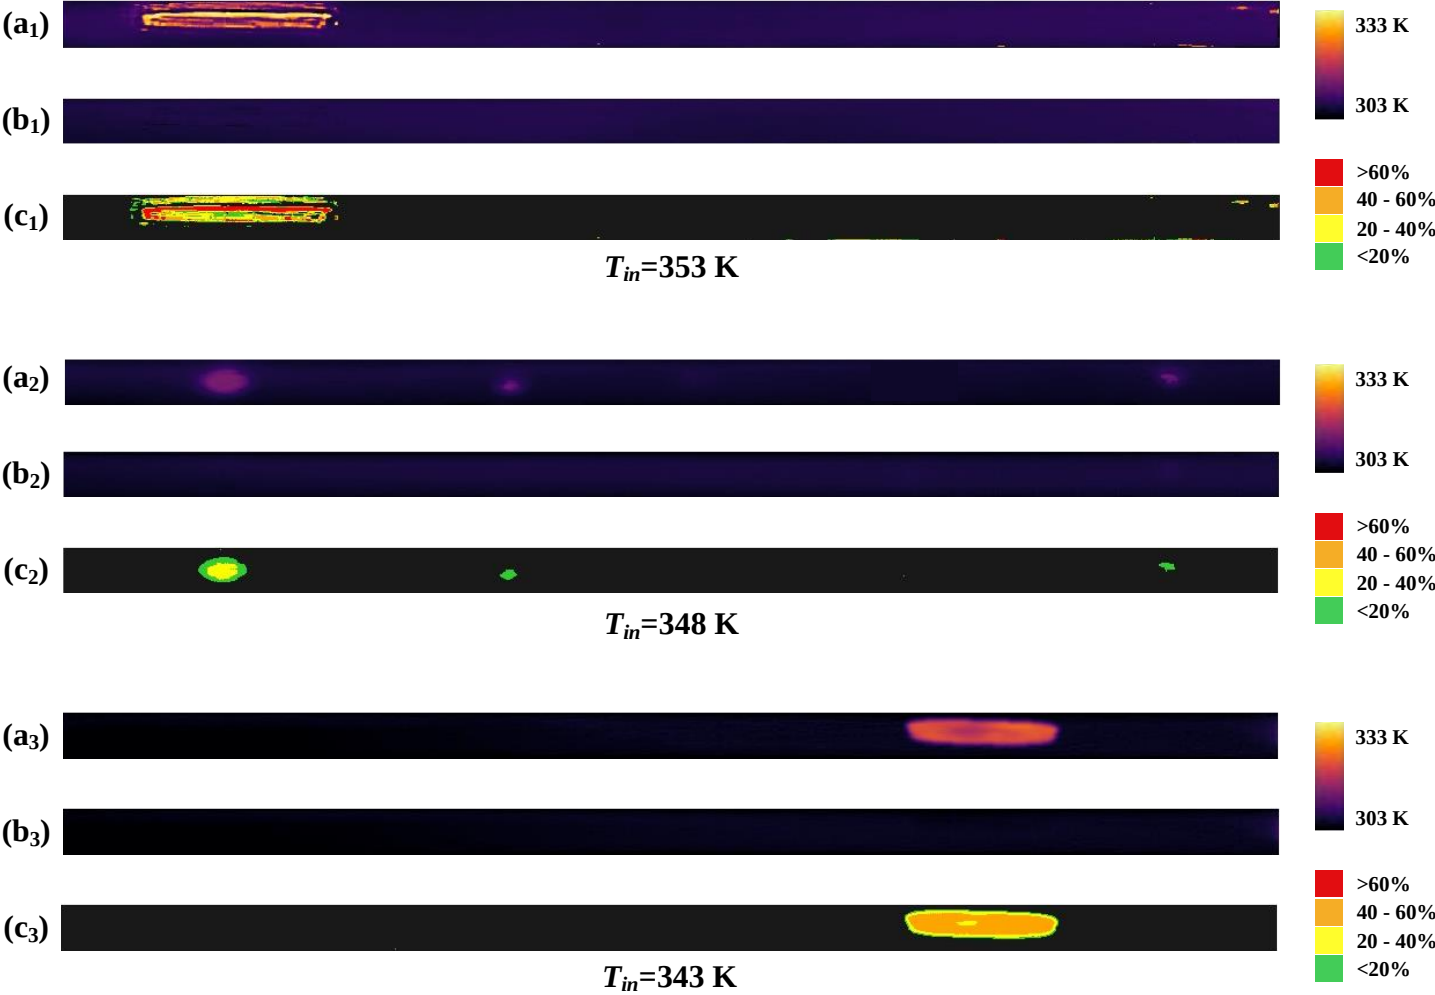
*1"pipe with 13 mm insulation thickness*

(a) observed image

(b) Predicted baseline

(c) color-coded map
