# Reducing Methane Slip and Recycle Rates Through Advanced Packed Bed Design In A Demethanizer Column

**TNChE Asia 2026:**

**Session: Process Excellence & Optimization; Efficiency Enhancement**

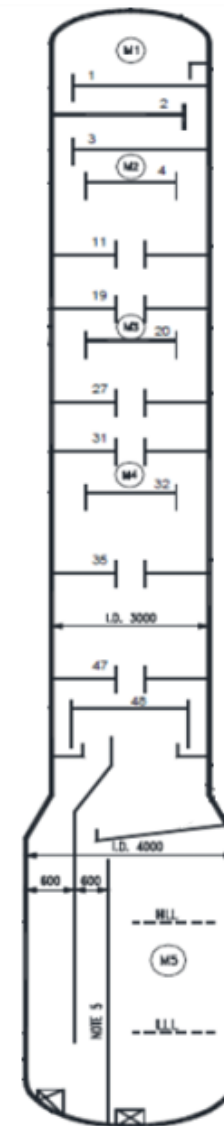
- This column was originally designed with 48 trays
- Since startup in 2016, the column has been limited by hydraulic flooding and high pressure-drop, preventing operation at its 125 tph nameplate capacity

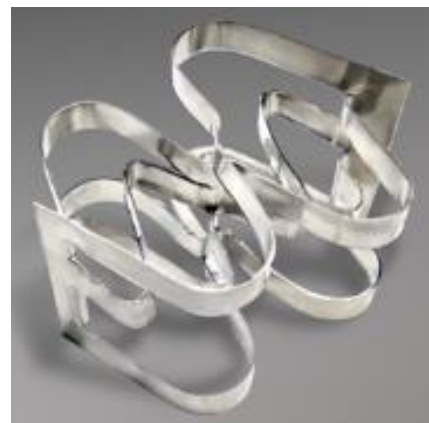
### Bed #1 - #2

- New liquid distributor
- New flash feed gallery

### Bed #3 → Bed #3 & #4

- Upgraded liquid distributor
- New high performance random packing, G-SR™
- Vapor Distributor Integrated with Chimney Tray

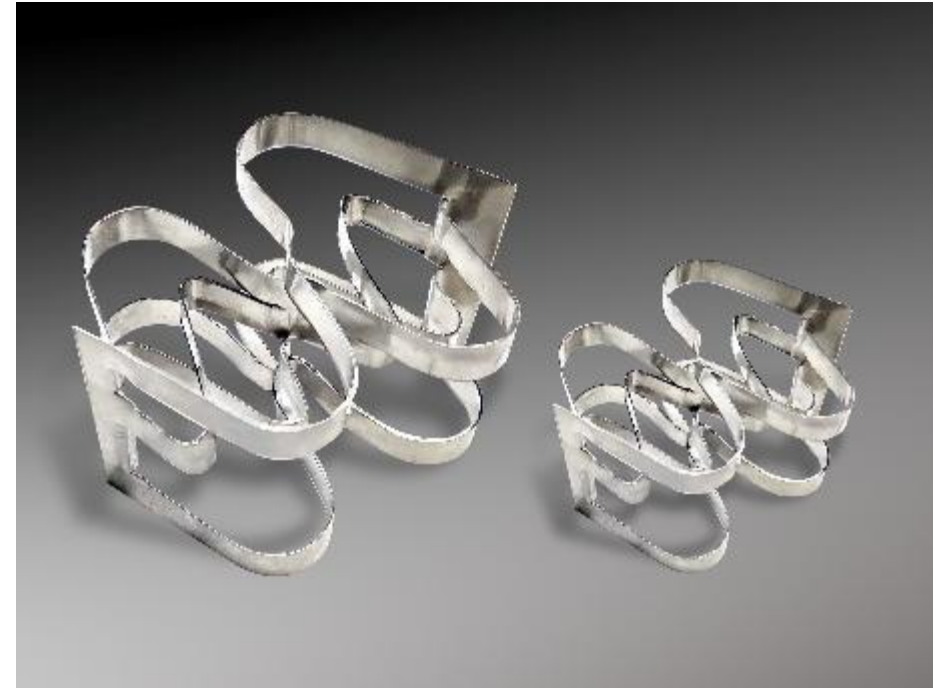
- Split Bed #3 into Two Beds
- Existing support rings reused from previous tray installation
- Rods tack-welded as needed to existing rings

# 11 Two-Bed Configuration Achieved Without Tower Shell Modifications

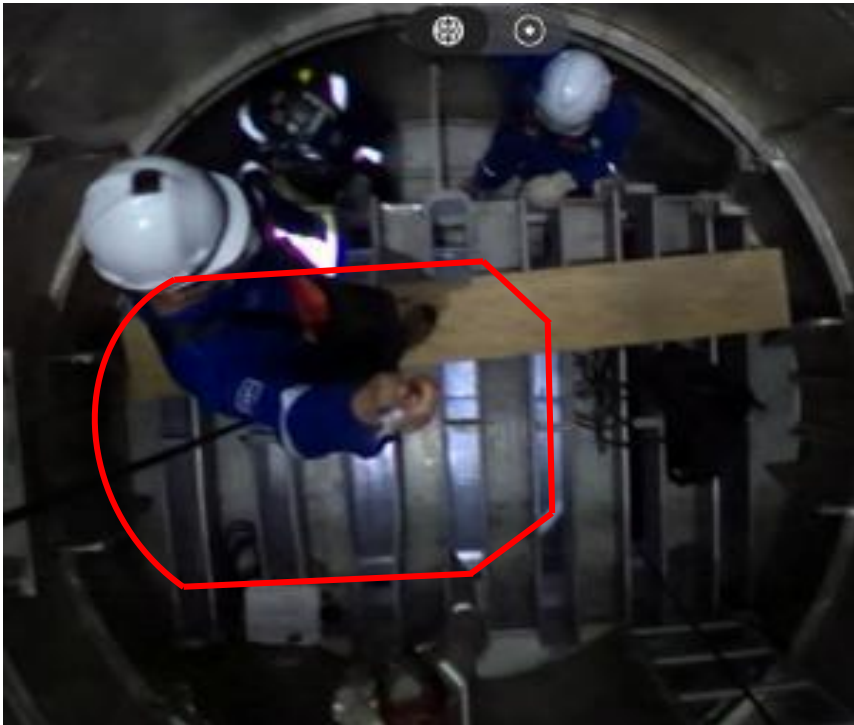
**Existing vapor distributor occupied a small portion of the column diameter, limiting effective vapor flow**
