8th Chemical Process Safety Sharing (CPSS)

CARBULIZATION in Steam Interchanger Dehydrogenation unit

Mr. Warawut Waiwasa
Process Engineer
IRPC

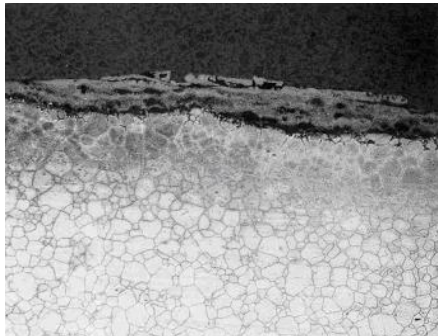
A photomicrograph of a cross-section of a 304H cyclone from a fluid coker showing surface carburization after 24 years. Mag. 35X.

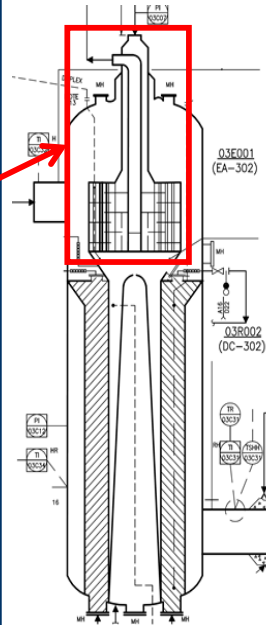
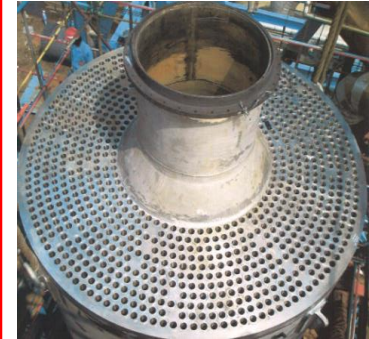
Steam interchanger

Shell	Tube
Materials	SS304H	SS304H
Design temperature (°C)	700-910	650
Operating temperature (°C)	801 (in)/ 632 (out)	567.7 (in)/620 (out)
Design pressure (barG)	2.1	1.8
Operating pressure (barG)	0.6	0.5
Service media	Steam	Effluent
Years in service	23	23

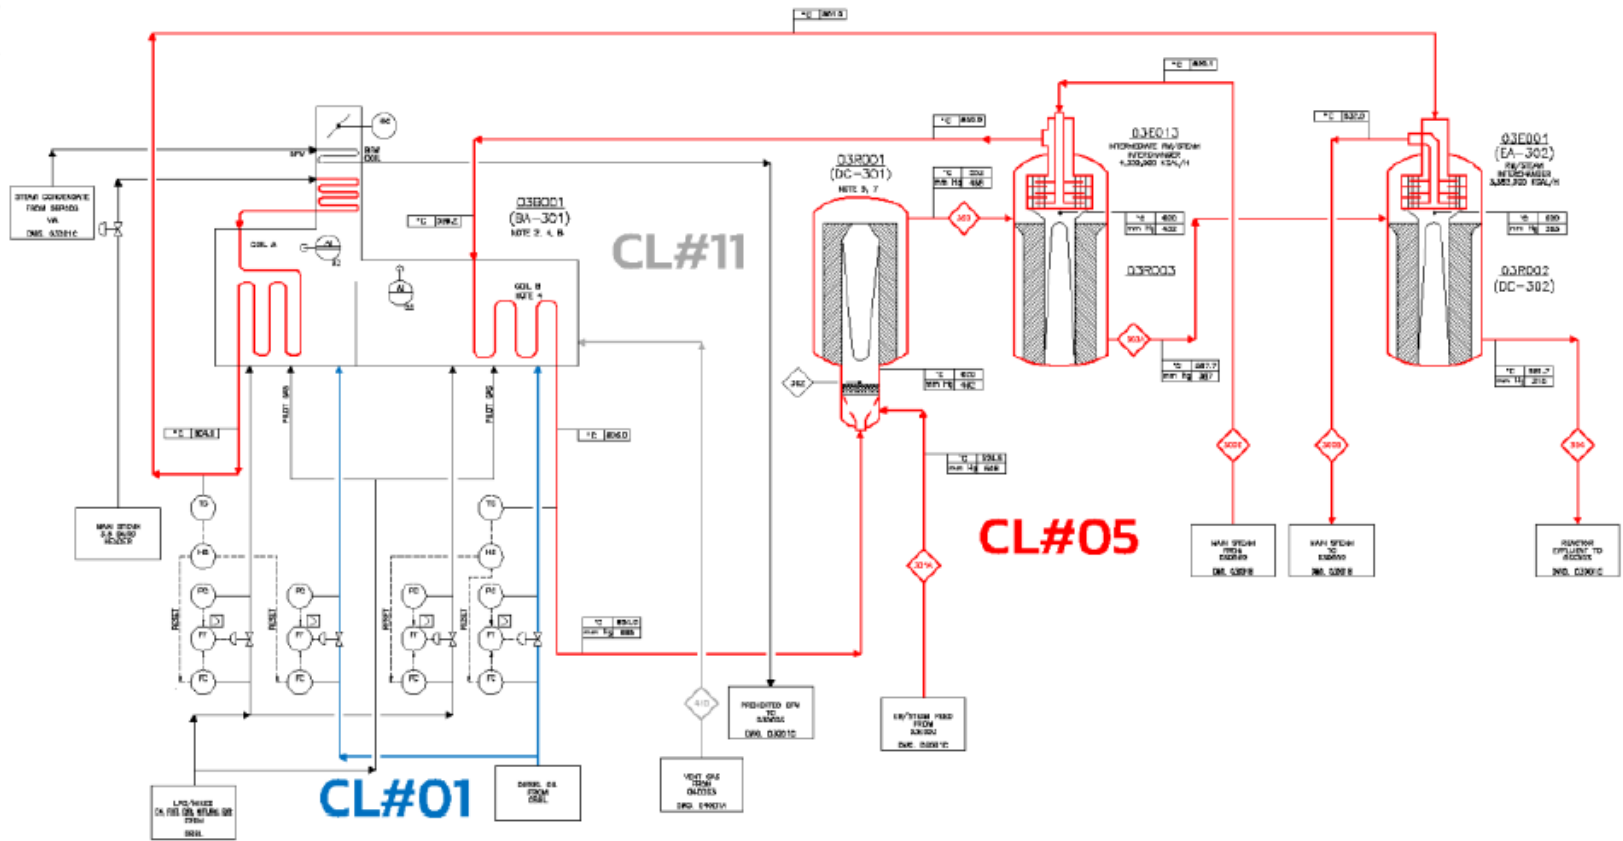
RBI indicated that **Carburization (CARBU)**, **Metal dusting (METDUS)**, Creep (CREEP), Sigma phase embrittlement (SIGPHEMB) and High temperature oxidation (HTOXID) could be take placed on the inter-exchanger .
