15th Chemical Process Safety Sharing (CPSS)

Topic: Aging Tank LOPC Prevention

Company : GC

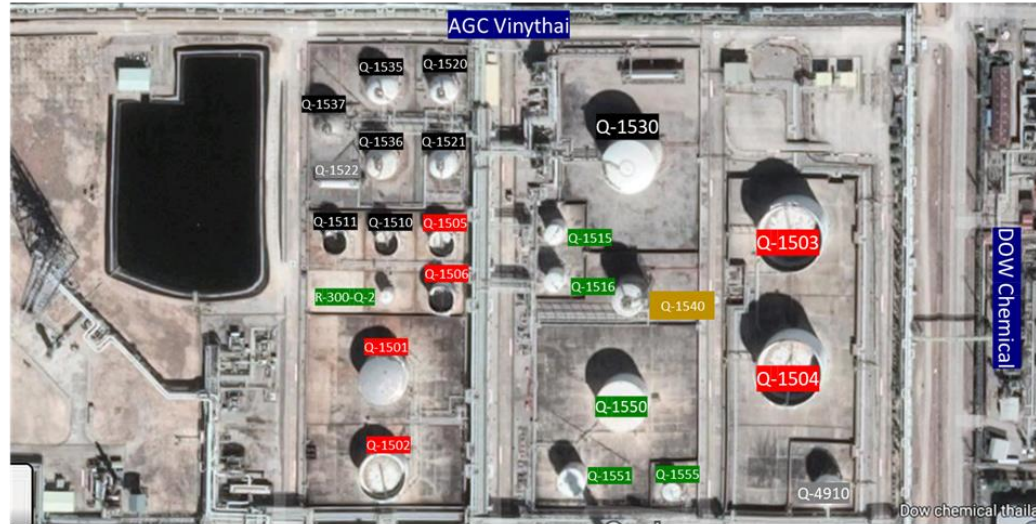
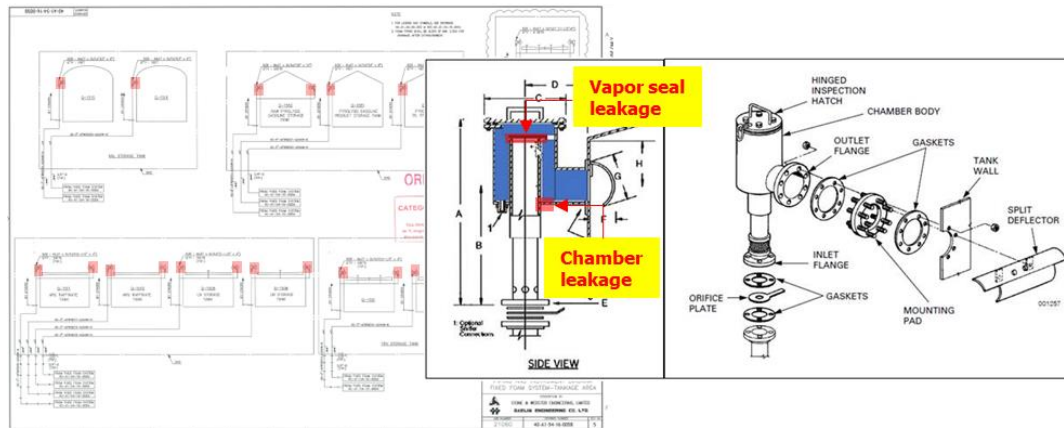
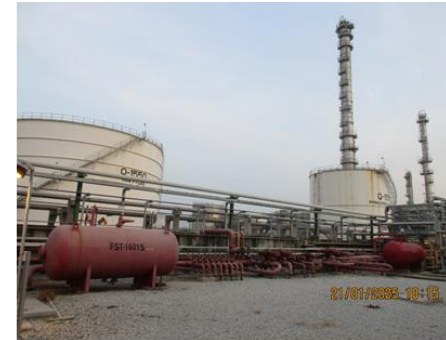
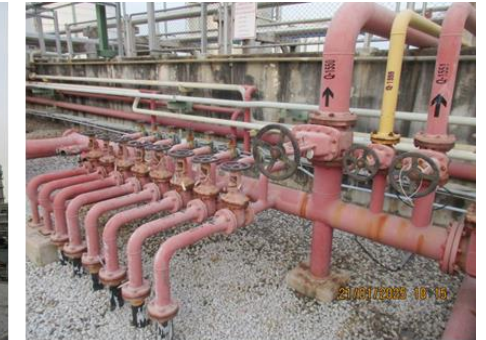
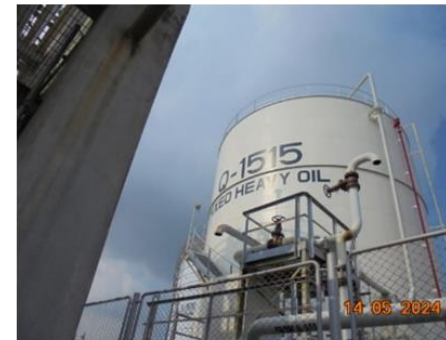
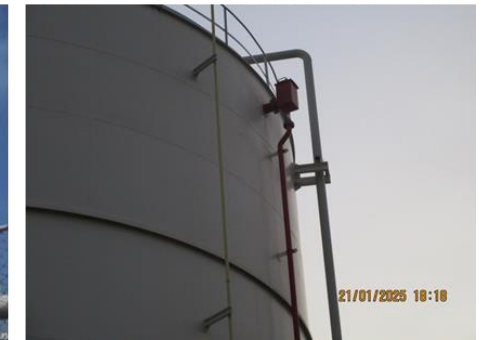
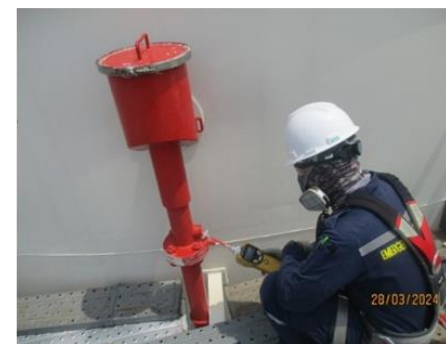
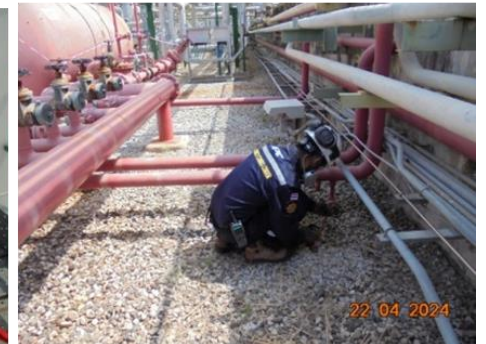
- During an FRA (Facility Risk Assessment) of a chemical storage tank, hydrocarbon vapor backflow was detected entering the foam chamber of the fire protection system.
- Vapor continued through the foam system and drained via the line drain.
- Measurement showed 100% LEL at the drain—indicating a critical explosion risk.

- The storage tank is over 30 years old, with signs of inadequate maintenance.
- Foam chamber equipment is deteriorated, increasing risks of vapor leakage and system failure.

- Installed **drain line caps** to prevent hydrocarbon vapor accumulation.
- Conducted **VOC monitoring** using portable devices and alarm systems.
- Repaired and wrapped **leak points** on vapor seal and rundown line.
- Planned **Roof Leg replacement** on degraded tanks.
